Navajo Abandoned Uranium Mine Site Screen Report

Eunice Becenti AUM Site

Navajo AUM Eastern Region

May 2009

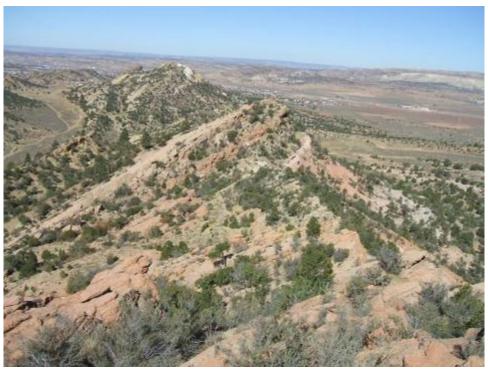
Reclamation status of the mine site is currently unknown. No visible signs of reclamation were observed. No waste piles, adits, or other mine features were observed during the site visit. The site was found alongside a large cliff-face, making much of the site inaccessible.

Photo 1. Eunice Becenti mine site, towards the north

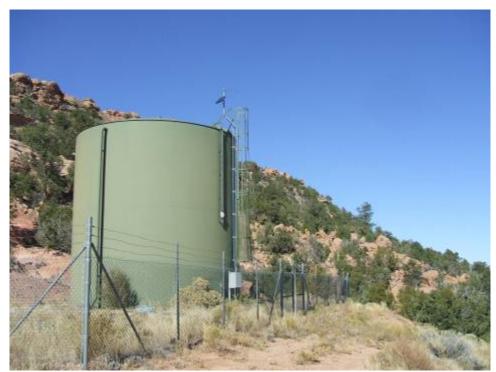
a 10,000 gallon tank near the houses 0.25 mile to the east (Photo 5), and a 30,000 gallon tank approximately 0.25 miles southeast of the site (Photo 2). Local residents stated that they collected water the tanks, but did not know the source of the water. Field personnel were unable to determine the source of the tanks. Gamma radiation levels at both tanks were found to be less than 2 times background

Photo 2. Eunice Becenti mine site, water tank at base of hill, approximately 0.25 miles south of site, towards the northwest

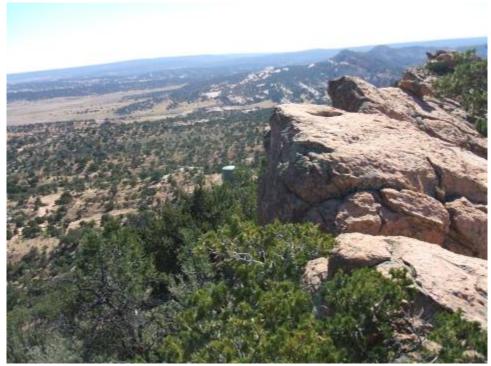
Photo 3. Eunice Becenti mine site cliff area, towards the south

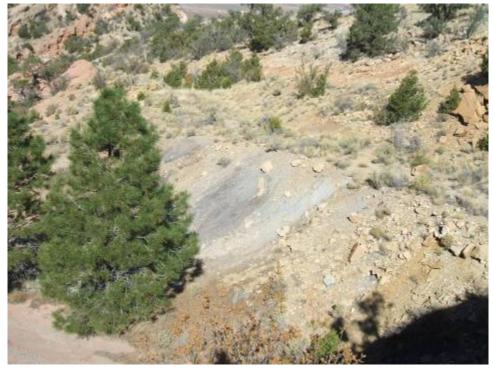
Photo 6. Eunice Becenti mine site, gravel and mudslide area, towards the north

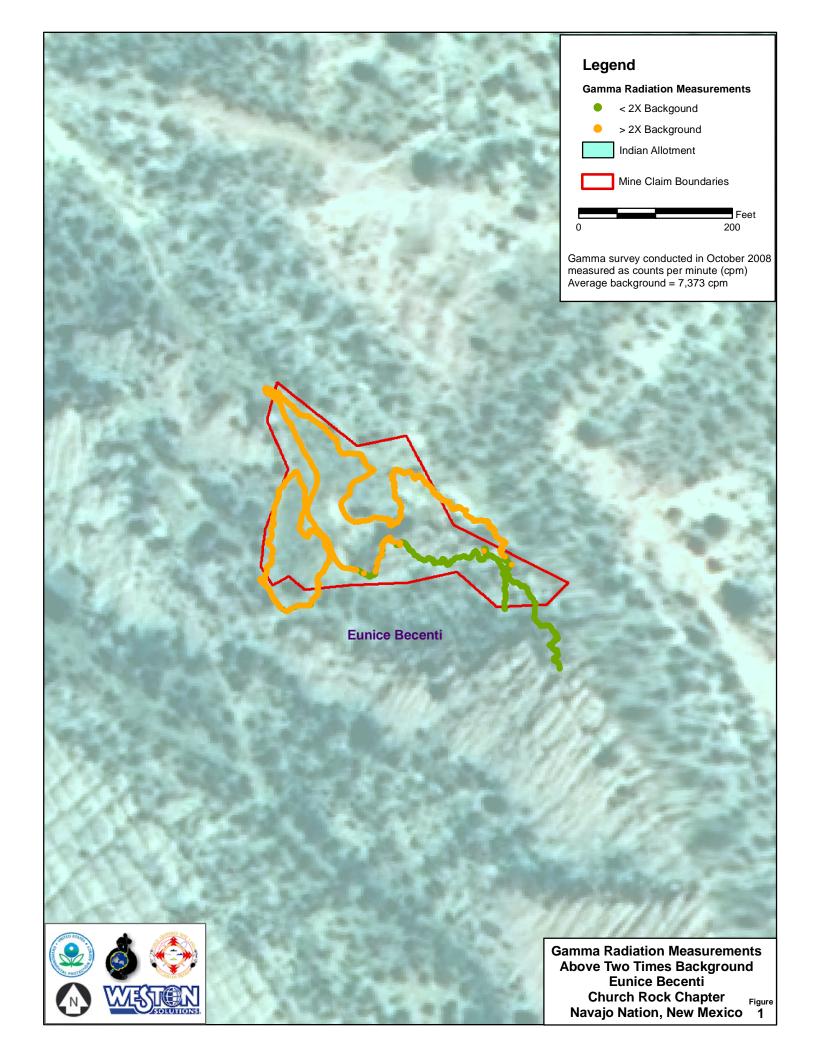
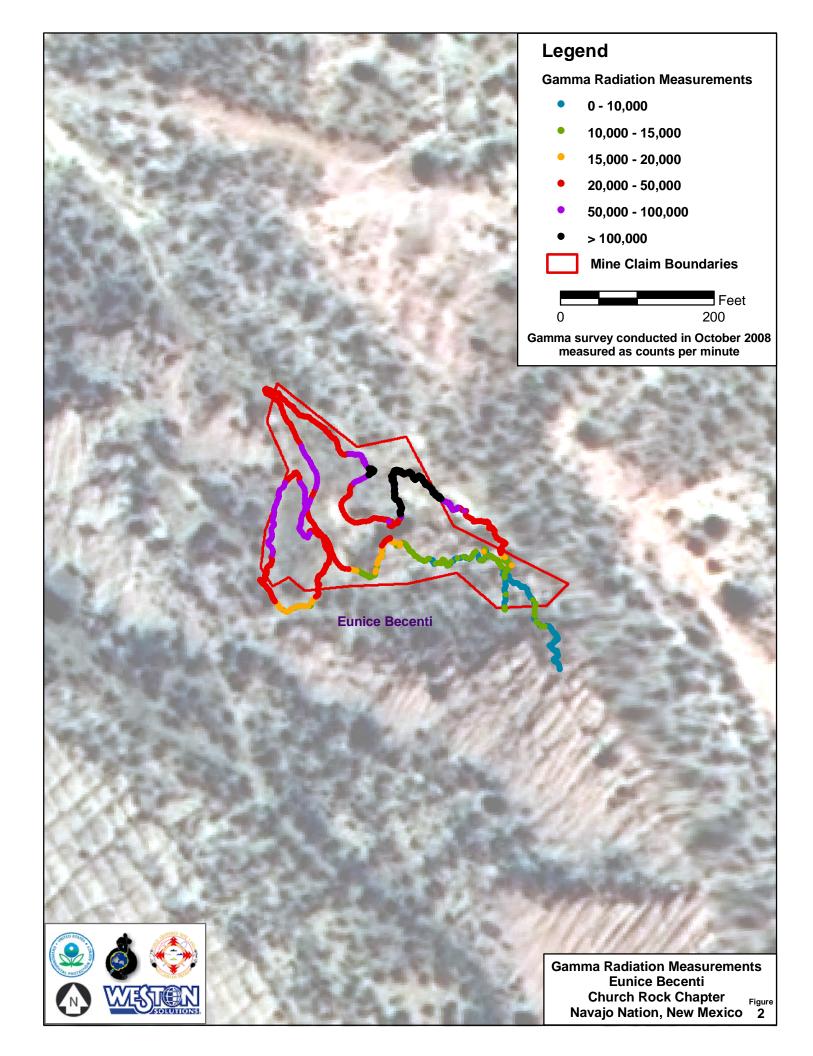
A total of 1,022 gamma radiation measurements were collected from mine sites, ranging from 5,141 cpm to 227,586 cpm. The measurements are represented in Figures 1 and 2.
